Left Hand Side Fuse

Typical Snag Checks

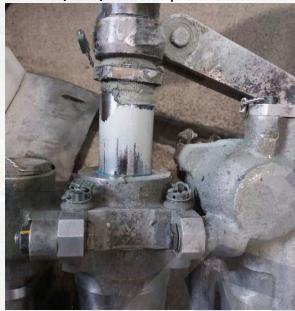
Grease / Dirt / Poor Finish - Pin Holes
