U.S. Department
of Transportation
**Federal Aviation
Administration**

June 10, 2021

Subject: Federal Aviation Administration (FAA) Approval of an Alternative Method of Compliance (AMOC) to Airworthiness Directives (AD) 2008-11-13, 2012-07-06, 2014-09-09, 2015-17-13, 2016-11-07, 2016-11-16 and 2015-25-08

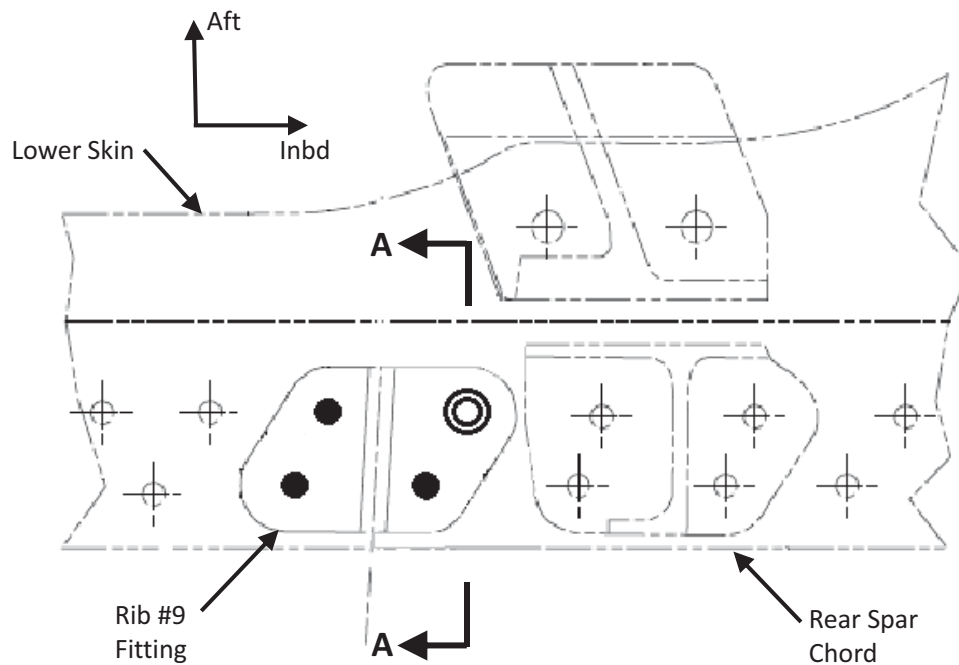
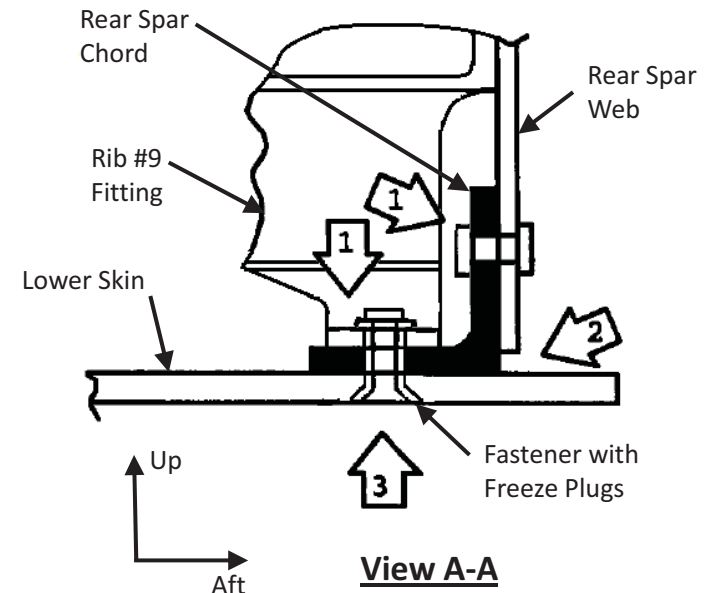
- Fastener with Freeze Plugs
 Adjacent fasteners requiring inspection for SSI 57-20-I01G
 Other fasteners (reference)

In the reworked area, perform the following inspections:

- 1) From direction 1, HFEC inspect the rear spar lower chord per the 777 NDT Manual Part 6, 51-00-01. Use the lower chord edges, radius, Rib #9 fitting shear tie foot and fastener collars on the vertical leg as a probe guide.
- 2) From direction 2, HFEC inspect the rear spar lower chord per the 777 NDT Manual Part 6, 51-00-01. Remove sealant as required. Use the rear spar web lower edge as a probe guide.
- 3) From Direction 3, inspect the rear spar lower chord at the freeze plug fastener location per 777 NDT Manual Part 6, 57-20-01.
- 4) Inspect the remaining 3 adjacent fastener locations as required for SSI 57-20-I01G.
