U.S. Department
of Transportation
**Federal Aviation
Administration**

June 10, 2021

Subject: Federal Aviation Administration (FAA) Approval of an Alternative Method of Compliance (AMOC) to Airworthiness Directives (AD) 2008-11-13, 2012-07-06, 2014-09-09, 2015-17-13, 2016-11-07, 2016-11-16 and 2015-25-08

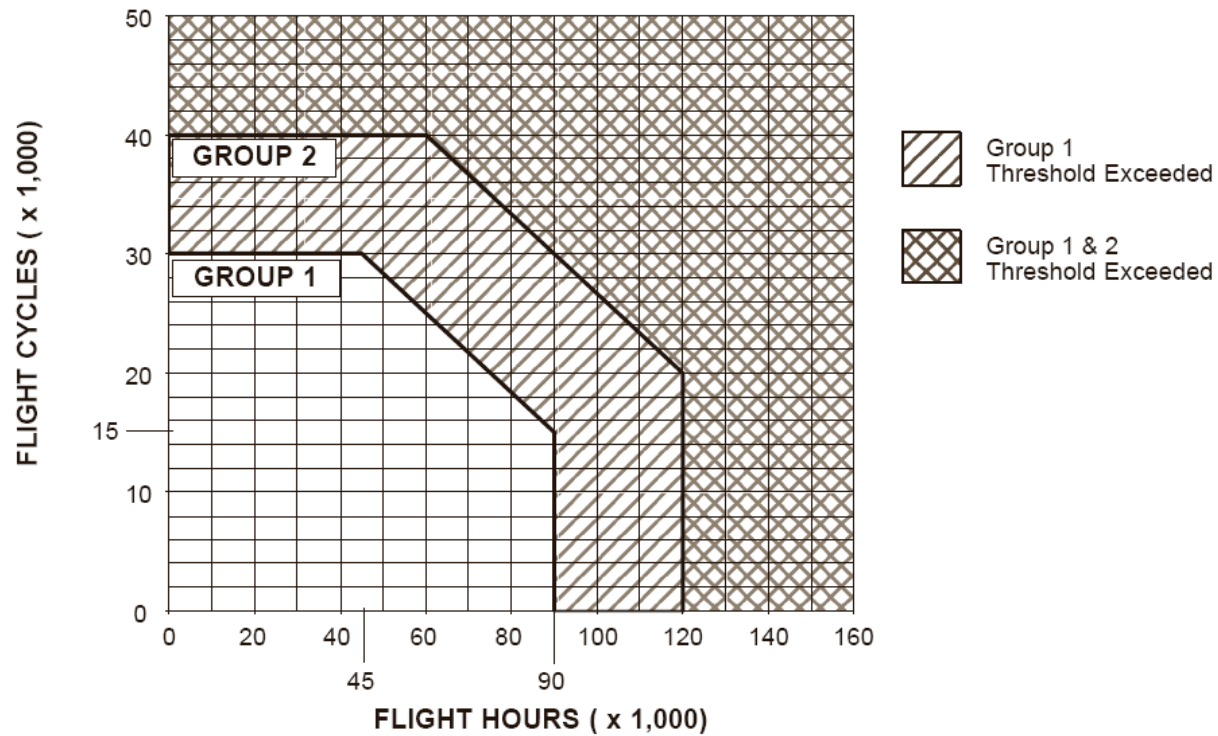
FIGURE 1. FLIGHT LENGTH SENSITIVE (FLS) THRESHOLD CURVE (777-200/200LR/300/300ER ONLY)

NOTE: In Figure 1 and the discussion of flight length sensitive threshold that immediately follows this note, "777-200" includes airplanes sometimes referred to as 777-200ER or 777-200IGW since those airplanes are certified as 777-200 airplanes per the applicable FAA Type Certificate.

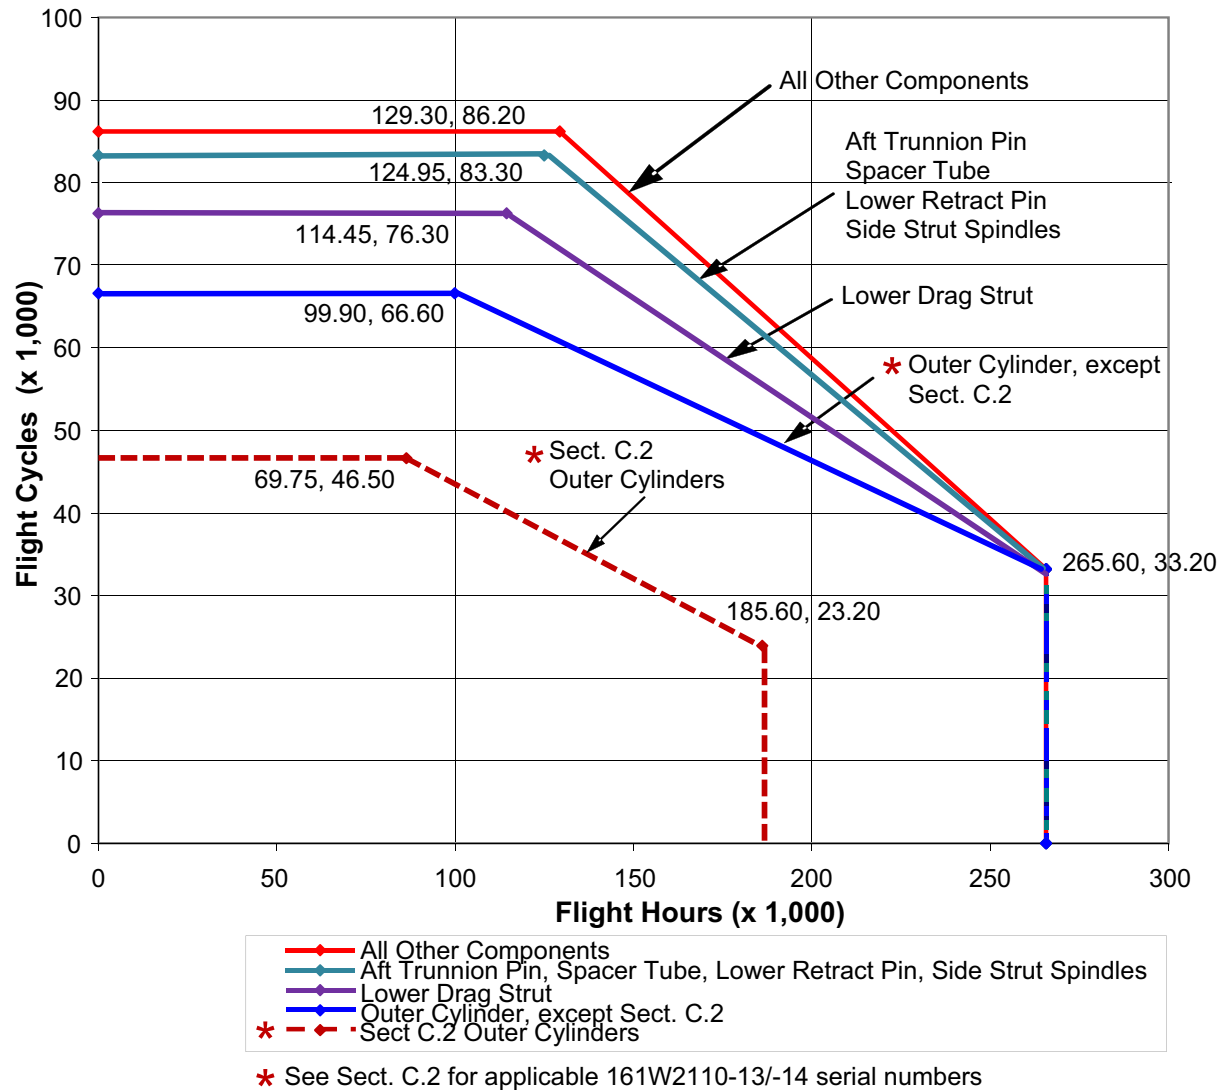
FIGURE 5. 777-200LR/300ER/777F MAIN LANDING GEAR SAFE-LIFE LIMITS

Revised Figure 5: 777-200LR/300ER/777F MLG Safe-Life Limits to reflect the addition of the life limit curve for outer cylinders as indicated in Section C.2.

777-200LR/300ER/777F Main Landing Gear Outer Cylinder NOTE: Life Limitation applies to P/N 161W2110-13 (LH) and 161W2110-14 (RH) Outer Cylinders with Serial Numbers: 161W2110-13: S/N WHM5001, WHM5002, WHM5003, WHM5007, WHM5017, WHM5021, WHM5023, WHM5033, WHM5039, WHM5041, WHM5045, WHM5047, WHM5053. 161W2110-14: S/N WHM5002, WHM5003, WHM5008, WHM5010, WHM5012, WHM5014, WHM5020, WHM5032, WHM5036, WHM5040, WHM5046, WHM5048, WHM5052.	Figure 5
