## AIRWORTHINESS LIMITATIONS (AWLS) AND CERTIFICATION MAINTENANCE REQUIREMENTS (CMRS)

**AMP Reference:** IAL/777/T Revision 00 Initial

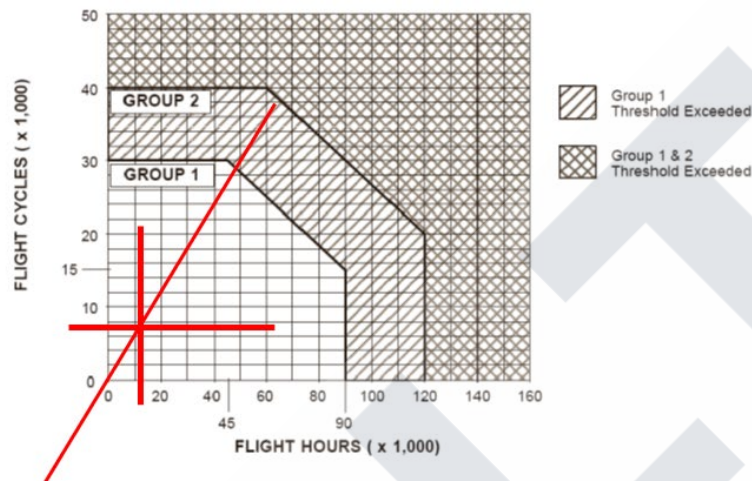
FIGURE 1. FLIGHT LENGTH SENSITIVE (FLS) THRESHOLD CURVE (777-200/200LR/300/300ER ONLY)

NOTE: In Figure 1 and the discussion of flight length sensitive threshold that immediately follows this note, "777-200" includes airplanes sometimes referred to as 777-200ER or 777-200IGW since those airplanes are certified as 777-200 airplanes per the applicable FAA Type Certificate.

The Structural Inspections Table defines the Inspection Implementation Threshold for the 777-200/200LR/300/300ER. Some items are sensitive to flight length and are identified by FLS in the Threshold column of the Structural Inspections Table (See Figure 1). Flight Length Sensitive (FLS) Items require both flight hours and flight cycles to determine the Implementation Threshold. Refer to Figure 1 to determine the threshold for FLS Items.

For those items which are not flight length sensitive, the lowest threshold shown in the Structural Inspections Table is 30,000 flights. Exceptions to this requirement are SSI 54-51-I02R, which has a threshold of 28,600 flights for the 777-200LR/300ER, and SSIs 28-00-I01A and 28-00-I01B have a threshold of 11,250 flights for the 777-200LR airplanes that have the optional auxiliary fuel tank installations. All other 777-200LR/300ER items which are not flight length sensitive have either a 30,000-flight threshold or 40,000 flight threshold depending upon whether the item is identified as Group 1 or Group 2. The minimum threshold for those items which are identified as flight length sensitive must be determined from Figure 1, based upon the actual airplane utilization.

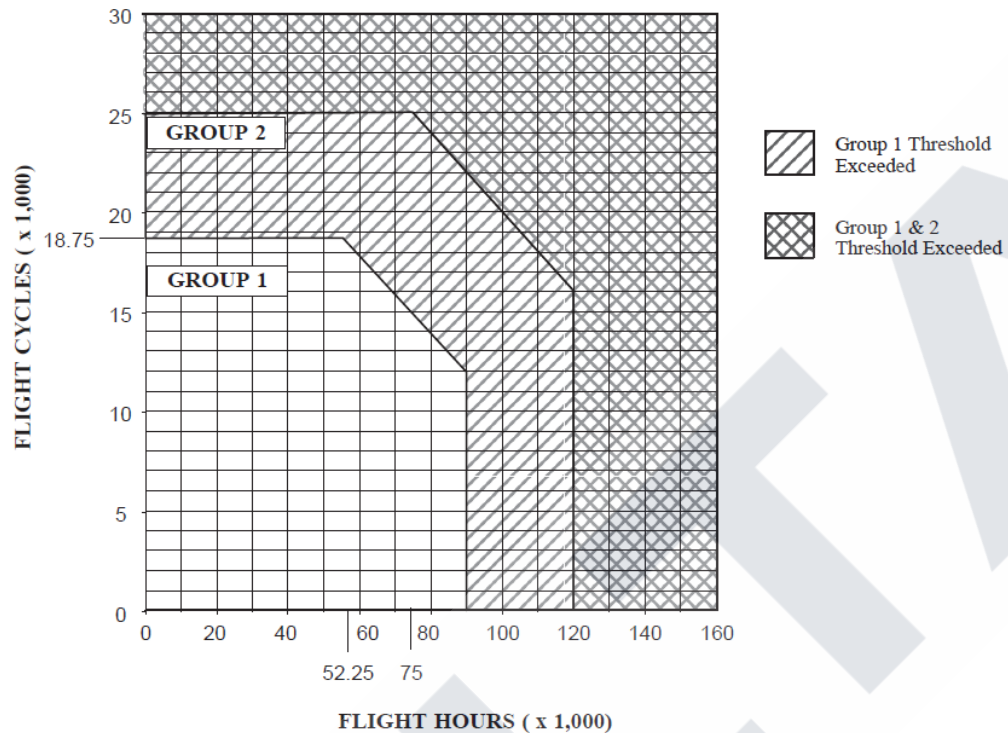
FIGURE 2. FLIGHT LENGTH SENSITIVE (FLS) THRESHOLD CURVE (777F ONLY)

“FLS” Group 1 items must be within one inspection interval of the threshold and must never exceed the Group 2 limit in Figure 2. “FLS” Group 2 items must never exceed the Group 2 limit in Figure 2. The threshold for 777F aircraft fatigue inspections is defined in the Structural Inspections Table.

The Structural Inspections Table defines the Inspection Implementation Threshold for the 777F. Some items are sensitive to flight length and are identified by FLS in the Threshold column of the Structural Inspections Table (See Figure 2). Flight Length Sensitive (FLS) Items require both flight hours and flight cycles to determine the Implementation Threshold. Refer to Figure 2 to determine the threshold for FLS Items.

For those items which are not flight length sensitive, the lowest threshold shown in the Structural Inspections Table is 18,750 flights. All other 777F items which are not flight length sensitive have either a 18,750 flight threshold or 25,000 flight threshold depending upon whether the item is identified as Group 1 or Group 2. The minimum threshold for those items which are identified as flight length sensitive must be determined from Figure 2, based upon the actual airplane utilization.

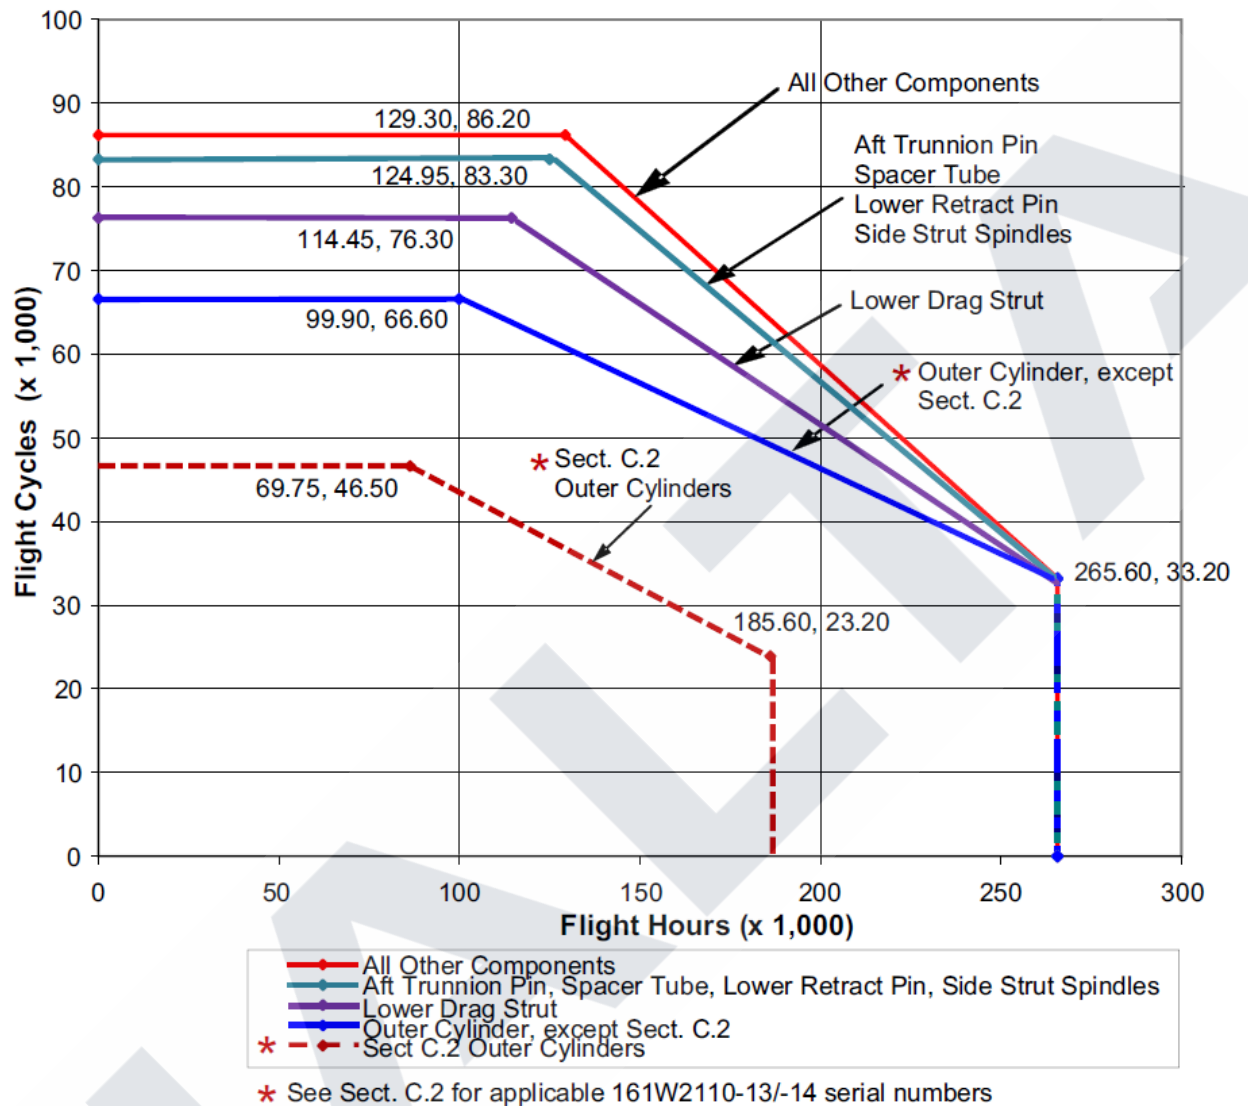
FIGURE 5. 777-200LR/300ER/777F MAIN LANDING GEAR SAFE-LIFE LIMITS

777-200LR/300ER/777F Main Landing Gear Outer Cylinder  NOTE: Life Limitation applies to P/N 161W2110-13 (LH) and 161W2110-14 (RH) Outer Cylinders with Serial Numbers:  161W2110-13: S/N WHM5001, WHM5002, WHM5003, WHM5007, WHM5017, WHM5021, WHM5023, WHM5033, WHM5039, WHM5041, WHM5045, WHM5047, WHM5053.  161W2110-14: S/N WHM5002, WHM5003, WHM5008, WHM5010, WHM5012, WHM5014, WHM5020, WHM5032, WHM5036, WHM5040, WHM5046, WHM5048, WHM5052.	Figure 5

1. For each safe life component, determine the accumulated flight cycles and flight hours.
2. Enter the Safe-Life Limit Curve at the appropriate flight cycles and flight hours and locate the intersection.
3. If the point determined in Step 2 lies below the Safe-Life Limit Curve, the component has not reached the Safe-Life Limit. If the point is on, above, or to the right of the Safe-Life Curve, then the Safe-Life Limit has been reached.

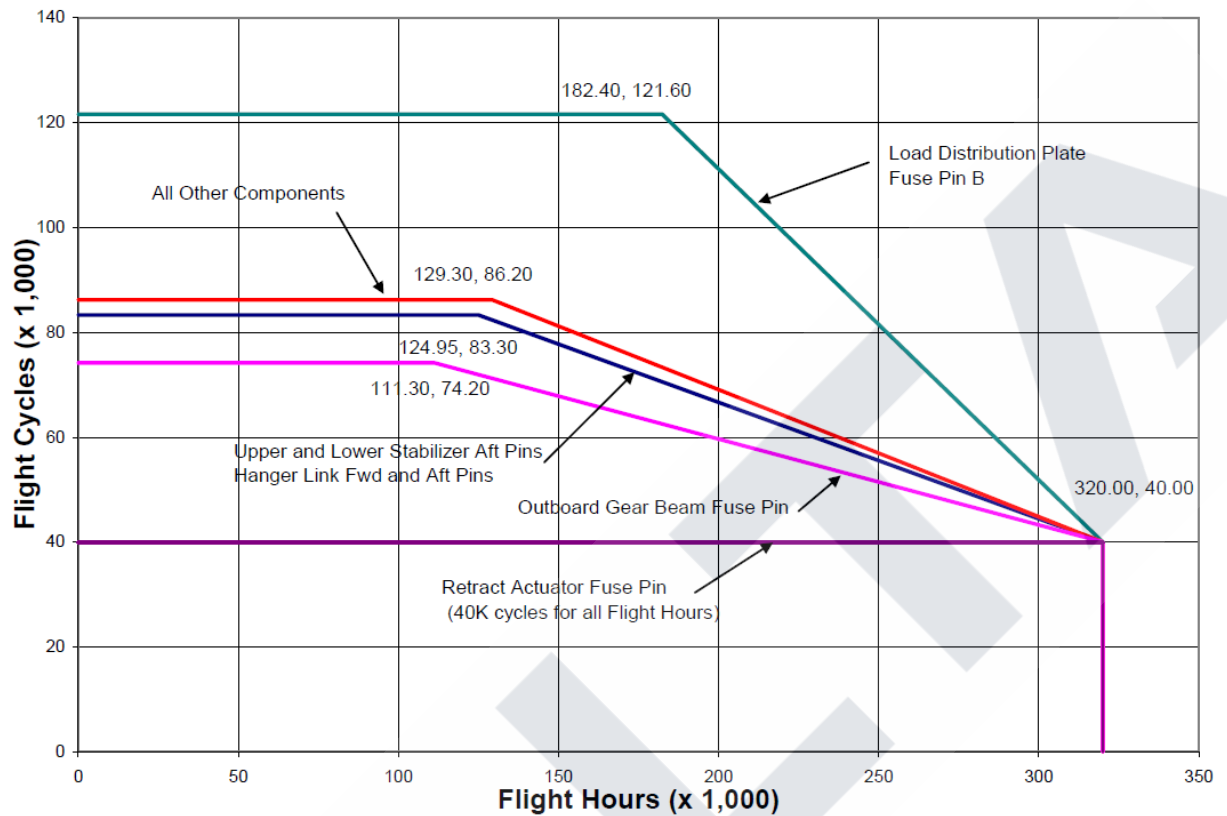
FIGURE 6. 777-200LR/300ER/777F MAIN LANDING GEAR SUPPORT FITTINGS SAFE-LIFE LIMITS

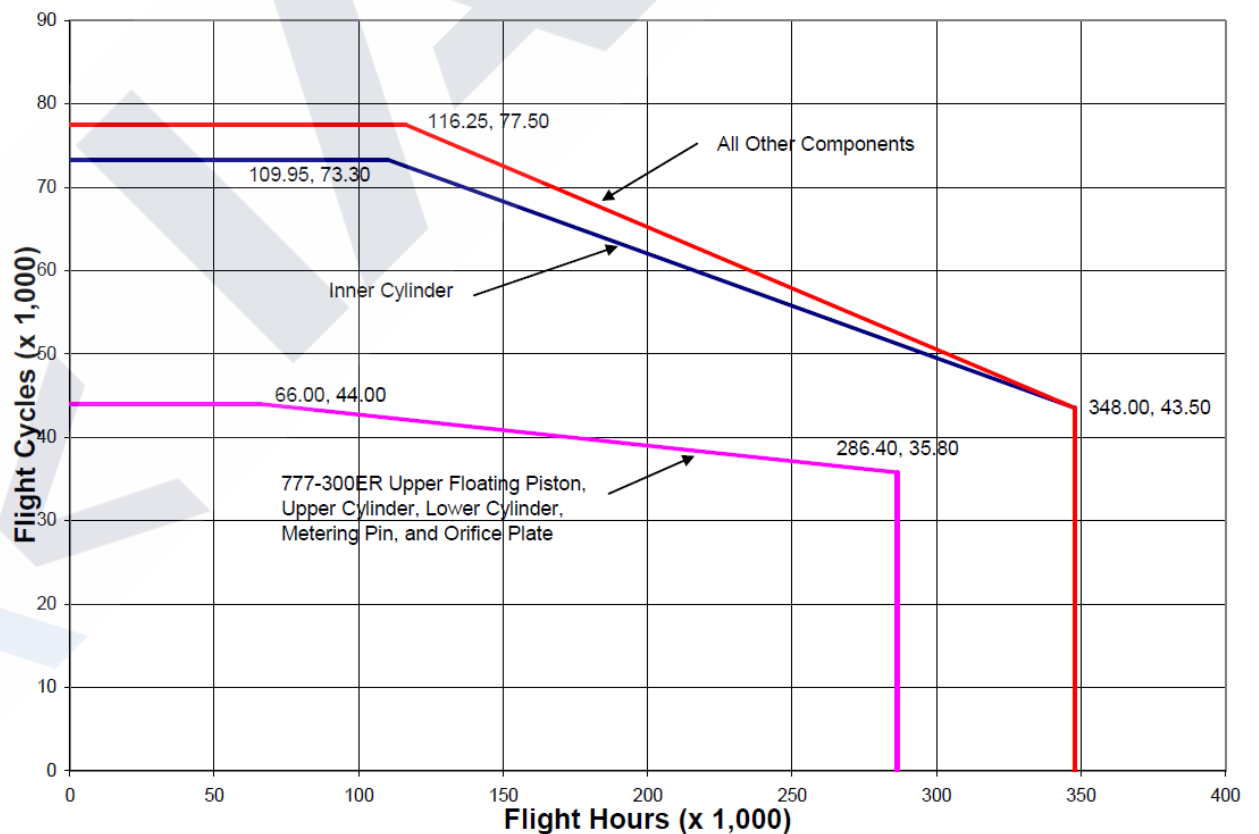
FIGURE 7. 777-200LR/300ER/777F NOSE LANDING GEAR SAFE-LIFE LIMITS  
IALTA Continued Airworthiness Management CAME
